# Township of Cheltenham

## Board of Historical and Architectural Review

### GUIDELINES FOR ROOFING

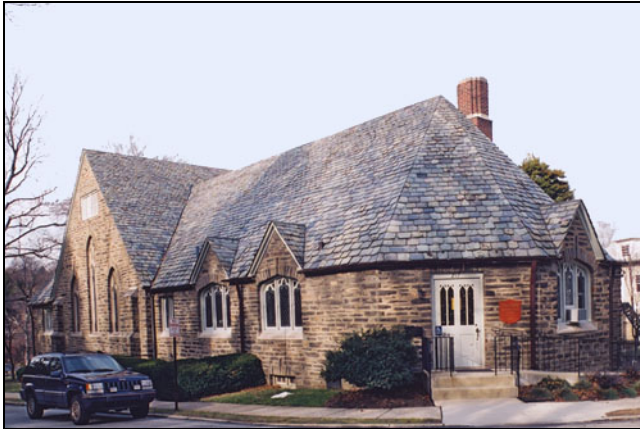
*The roof slates at this church are varied in color, size and thickness. Larger slates are located at the roof eaves with smaller slates at the ridge. This graduating pattern makes the roof appear visually larger. The gable dormers break up the continuous eave line.*

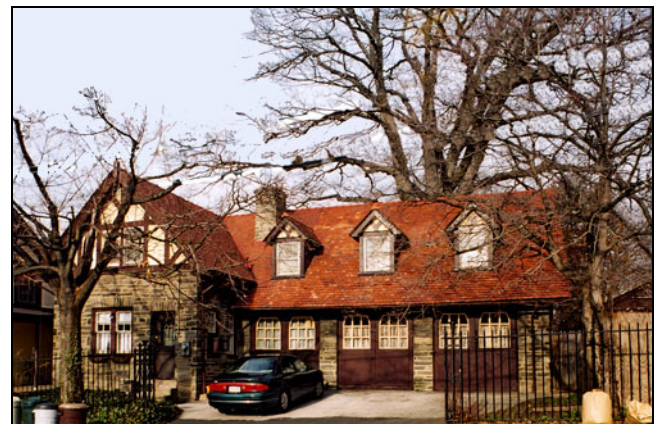
*The terra cotta roof tiles are a distinctive and dramatic feature of this Tudor Revival residence. Also note the overhanging eaves, gable roof dormers and stone chimney protruding at the roof ridge.*

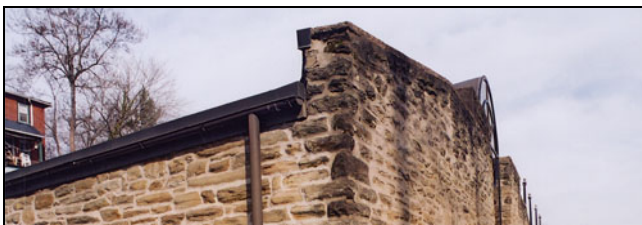
*This shallow sloped roof terminates at a decorative parapet.*

- **Flat Roofs** might be a true horizontal plane or have a low pitch to allow for drainage. Flat roofs often terminate at a parapet, generally an extension of the building's exterior walls.

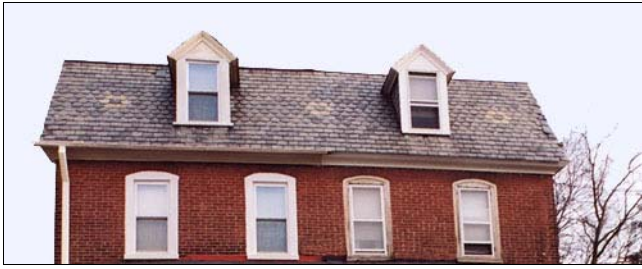
*The banded slate shapes and the addition of a color pattern enhance this simple twin house.*

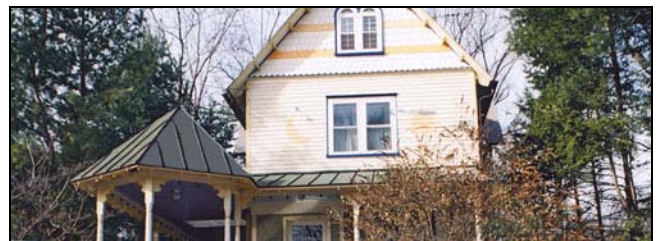
*Standing seam metal roofing can be found at steeply pitched roofs, while flat seam metal roofing is more typical at shallower roofs.*

Metal was popularized for roofing after sheet metal production was expanded following the Civil War. Traditional sheet roofing metals include lead, copper, zinc, tin plate, tern plate and galvanized iron. Many metal roofs require painting with traditional colors including red, silver, green or black. On shallow pitch roofs like porches, cupolas or domes, small rectangular pieces of flat seam metal roofing were installed with edges crimped together and soldered to form a weather-tight surface. On steeper pitched roofs, long continuous seam were used, either in a standing seam or batten seam configuration, providing regular ridges down roof slopes.

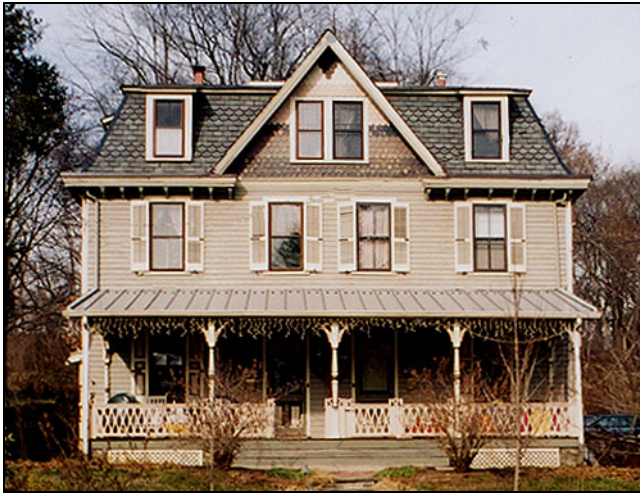
*The slates on this Mansard roof were replaced with dimensional asphalt shingles to replicate the color and pattern of the original.*

If property owners are replacing an existing slate or wood roof with asphalt, they are encouraged to choose a style and color that appears similar to the original material, installed with similar colors and patterns.

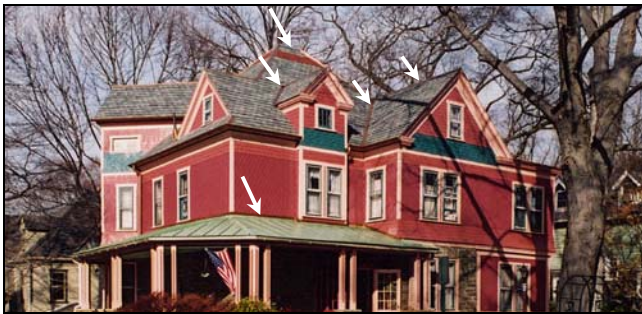
*The arrows indicate typical flashing locations.*

**Flashing** is made of thin sheet metal formed to prevent water from entering a building at joints, intersections and changes of pitch. It is typically installed around chimneys, parapet walls, dormer windows, roof valleys, vents, and intersections of porches, additions or bays windows.

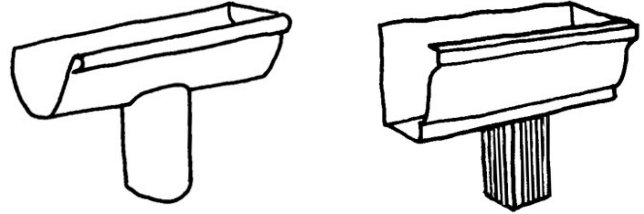
*Half-round gutters with round or rectangular downspouts are preferred to decorative gutters with corrugated downspouts.*

- Regular cleaning and maintenance of gutters and downspouts
- Retaining original drainage system and appearance
- Half-round gutters rather than a profiled K-gutter, which would compete with building features
- Plain round or rectangular downspouts which are more appropriate for use at historic buildings than corrugated downspouts

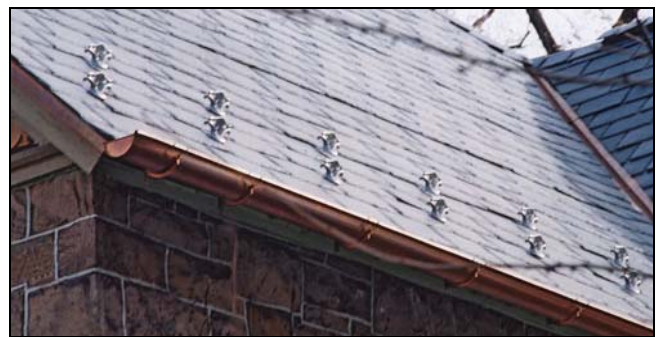
*Snow birds provide protection and a visual pattern at the edge of this roof. Note the half-round gutter installation.*

**Snow birds**, also known as snow guards, are typically a cast metal or bent wire devices attached in a staggered pattern near the eave of the roof utilized to prevent masses of snow from sliding off a roof. They were typically installed to protect eaves, cornice and gutters, and to take advantage of the insulating effect of snow.

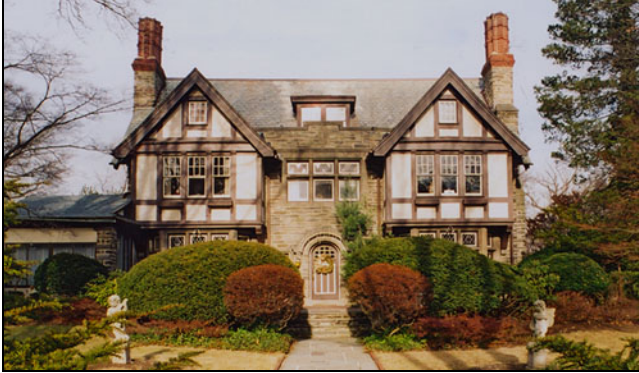
*The pair of fluted gable end brick chimneys is a characteristic of the Tudor Revival style, as is the central shed roof dormer.*

**Chimneys** were typically designed to compliment the style of a building and period of construction. In Cheltenham, many are constructed of brick with some stone, some of which have been covered with stucco. Early Federal style and Colonial Revival buildings tend towards square or rectangular chimney shafts, sometimes with molded caps. Victorian chimneys can include decorative detailing including corbelling, varied patterns, undulating and molded surfaces and decorative terra cotta chimney pots.

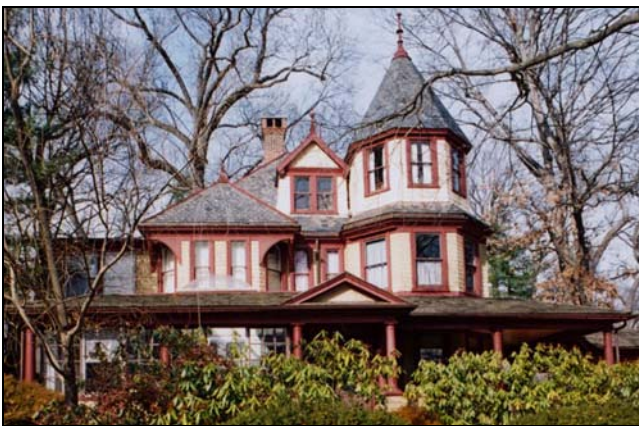
*The dormers, tower and chimney punctuate this Victorian roof.*

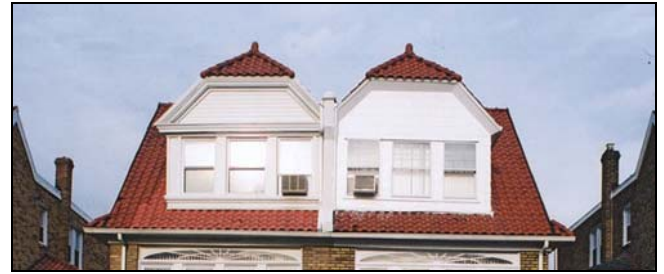
*Paired jerkin roof dormers provide additional inhabitable space at the upper level and interrupt the unifying side gable roof of these twin residences.*

**Dormers**, also known as dormer windows, protrude from the roof surface with a window at the downward slope, providing light and additional headroom under roof eaves. Dormers can have various roof shapes including gables, shed, hipped, eyebrow, segmented pediment and other shapes.

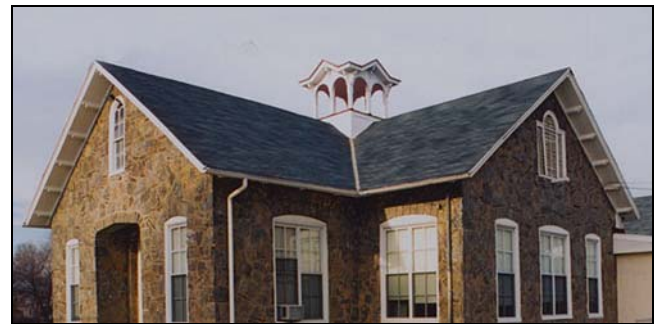
*The cupola is a defining feature of this building.*

**Cupolas**, also known as monitors or belvederes, are structures that project up from the roof, utilized for ventilation with louvers or as lookouts with windows.

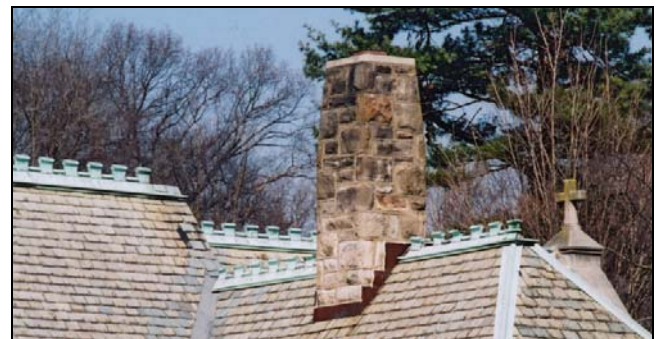
*The steeply pitched slate roof, large chimney and the ridge cresting add visual interest to this building.*

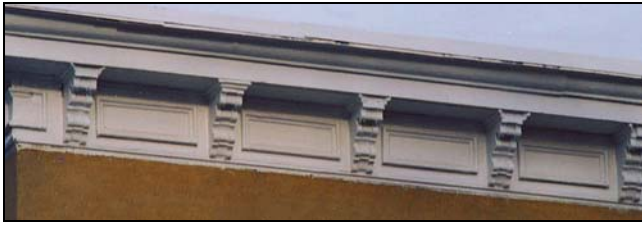
*Property owners are encouraged to maintain roof edge features like decorative cornices and trim, and not enclose them in siding.*
