Township of Cheltenham

Board of Historical and Architectural Review

GUIDELINES FOR ROOFING

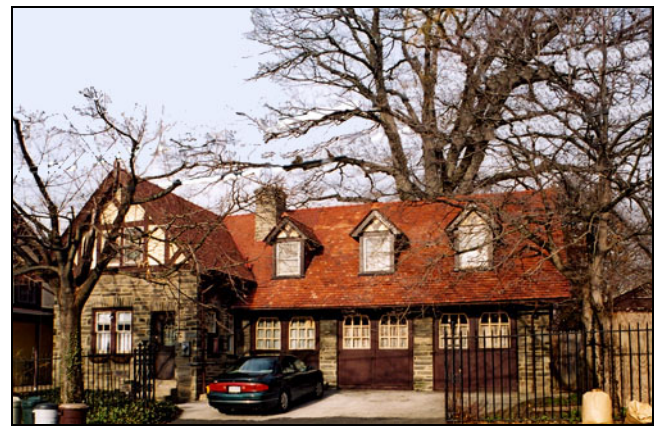
The terra cotta roof tiles are a distinctive and dramatic feature of this Tudor Revival residence. Also note the overhanging eaves, gable roof dormers and stone chimney protruding at the roof ridge.
