Township of Cheltenham

Board of Historical and Architectural Review

GUIDELINES FOR ROOFING

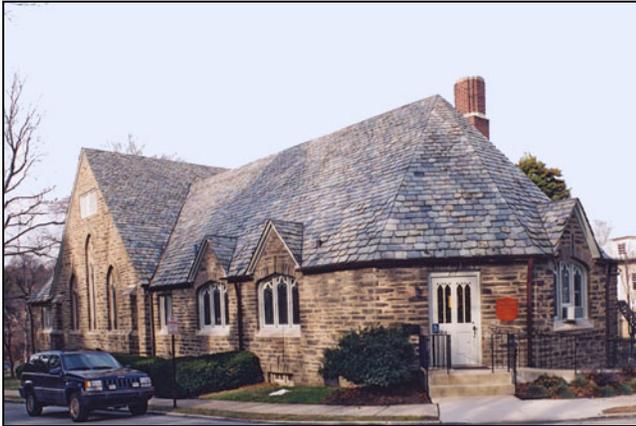
The roof slates at this church are varied in color, size and thickness. Larger slates are located at the roof eaves with smaller slates at the ridge. This graduating pattern makes the roof appear visually larger. The gable dormers break up the continuous eave line.

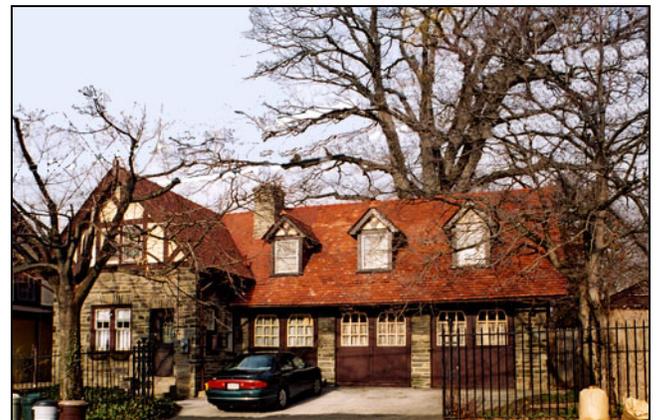
The terra cotta roof tiles are a distinctive and dramatic feature of this Tudor Revival residence. Also note the overhanging eaves, gable roof dormers and stone chimney protruding at the roof ridge.

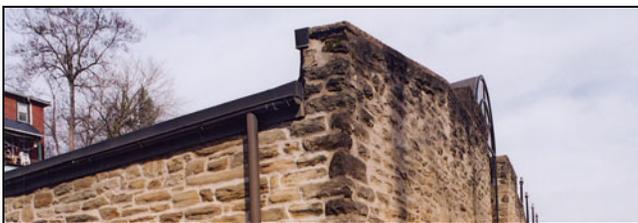
This shallow sloped roof terminates at a decorative parapet.

- **Flat Roofs** might be a true horizontal plane or have a low pitch to allow for drainage. Flat roofs often terminate at a parapet, generally an extension of the building's exterior walls.

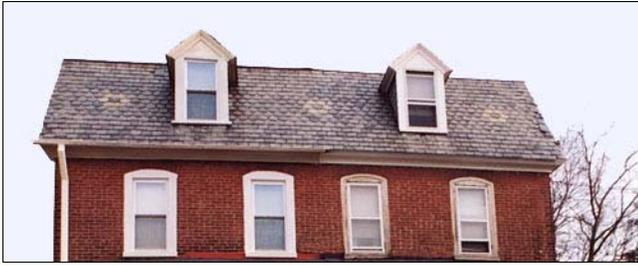
The banded slate shapes and the addition of a color pattern enhance this simple twin house.

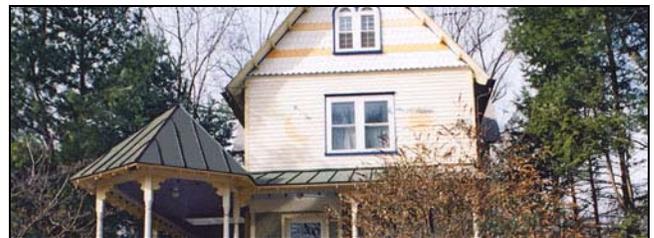
Standing seam metal roofing can be found at steeply pitched roofs, while flat seam metal roofing is more typical at shallower roofs.

Metal was popularized for roofing after sheet metal production was expanded following the Civil War. Traditional sheet roofing metals include lead, copper, zinc, tin plate, tern plate and galvanized iron. Many metal roofs require painting with traditional colors including red, silver, green or black. On shallow pitch roofs like porches, cupolas or domes, small rectangular pieces of flat seam metal roofing were installed with edges crimped together and soldered to form a weather-tight surface. On steeper pitched roofs, long continuous seam were used, either in a standing seam or batten seam configuration, providing regular ridges down roof slopes.

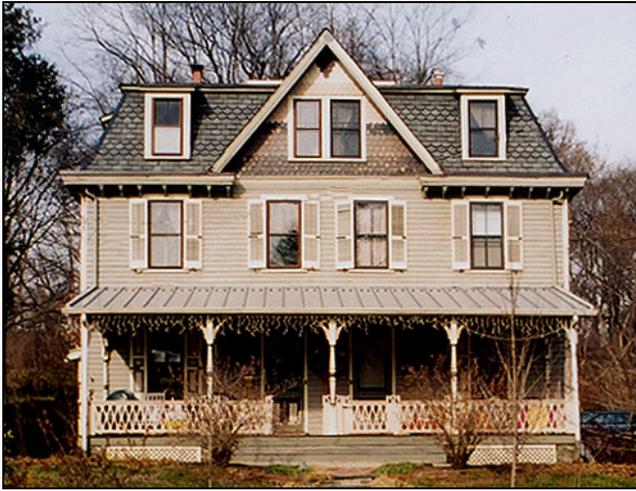
The slates on this Mansard roof were replaced with dimensional asphalt shingles to replicate the color and pattern of the original.

If property owners are replacing an existing slate or wood roof with asphalt, they are encouraged to choose a style and color that appears similar to the original material, installed with similar colors and patterns.

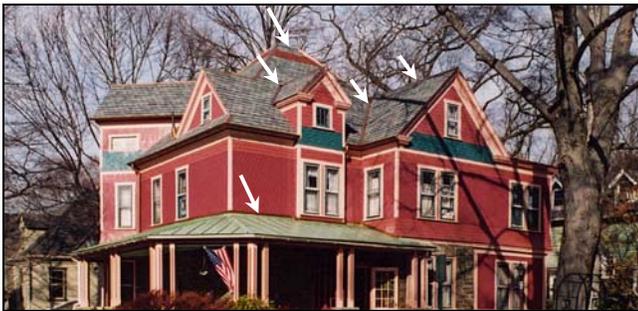
The arrows indicate typical flashing locations.

Flashing is made of thin sheet metal formed to prevent water from entering a building at joints, intersections and changes of pitch. It is typically installed around chimneys, parapet walls, dormer windows, roof valleys, vents, and intersections of porches, additions or bays windows.

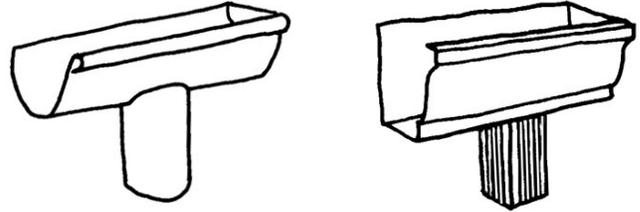
Half-round gutters with round or rectangular downspouts are preferred to decorative gutters with corrugated downspouts.

- Regular cleaning and maintenance of gutters and downspouts
- Retaining original drainage system and appearance
- Half-round gutters rather than a profiled K-gutter, which would compete with building features
- Plain round or rectangular downspouts which are more appropriate for use at historic buildings than corrugated downspouts

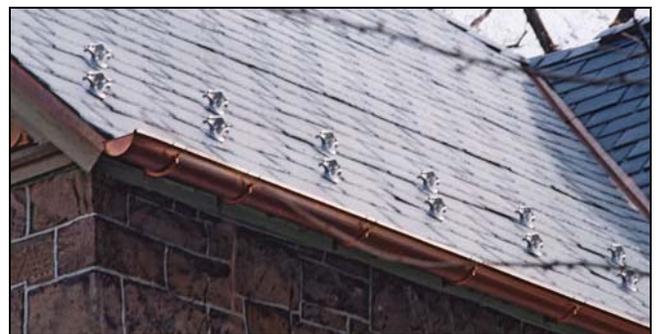
Snow birds provide protection and a visual pattern at the edge of this roof. Note the half-round gutter installation.

Snow birds, also known as snow guards, are typically a cast metal or bent wire devices attached in a staggered pattern near the eave of the roof utilized to prevent masses of snow from sliding off a roof. They were typically installed to protect eaves, cornice and gutters, and to take advantage of the insulating effect of snow.

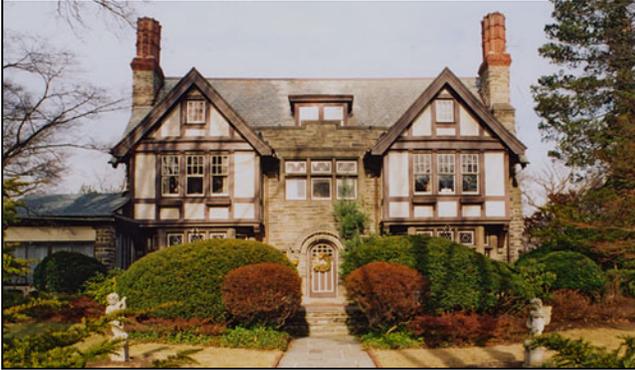
The pair of fluted gable end brick chimneys is a characteristic of the Tudor Revival style, as is the central shed roof dormer.

Chimneys were typically designed to compliment the style of a building and period of construction. In Cheltenham, many are constructed of brick with some stone, some of which have been covered with stucco. Early Federal style and Colonial Revival buildings tend towards square or rectangular chimney shafts, sometimes with molded caps. Victorian chimneys can include decorative detailing including corbelling, varied patterns, undulating and molded surfaces and decorative terra cotta chimney pots.

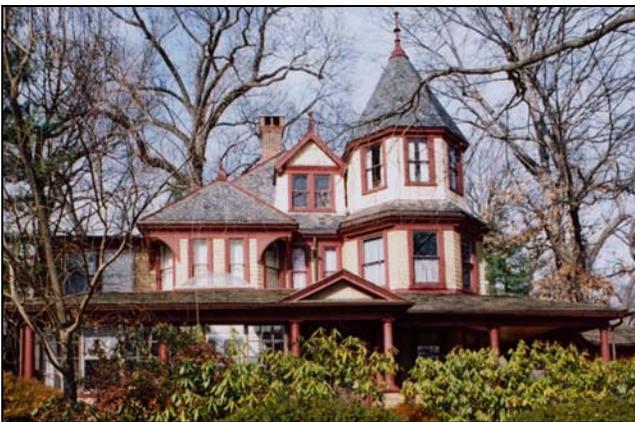
The dormers, tower and chimney punctuate this Victorian roof.

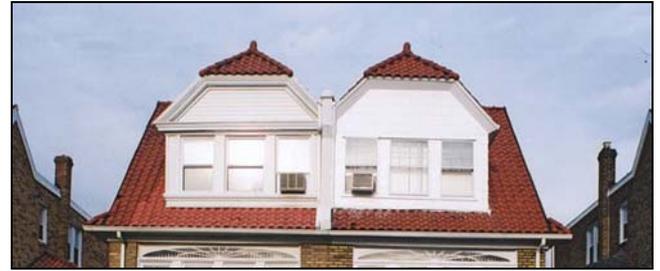
Paired jerkin roof dormers provide additional inhabitable space at the upper level and interrupt the unifying side gable roof of these twin residences.

Dormers, also known as dormer windows, protrude from the roof surface with a window at the downward slope, providing light and additional headroom under roof eaves. Dormers can have various roof shapes including gables, shed, hipped, eyebrow, segmented pediment and other shapes.

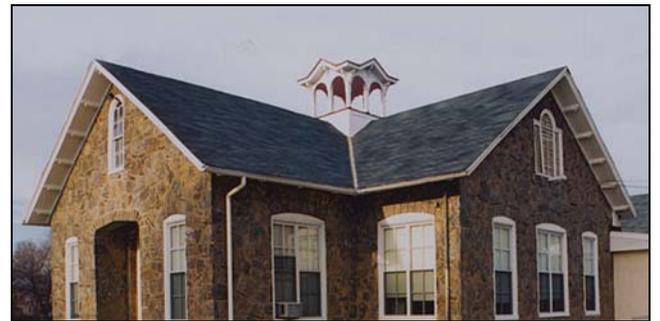
The cupola is a defining feature of this building.

Cupolas, also known as monitors or belvederes, are structures that project up from the roof, utilized for ventilation with louvers or as lookouts with windows.

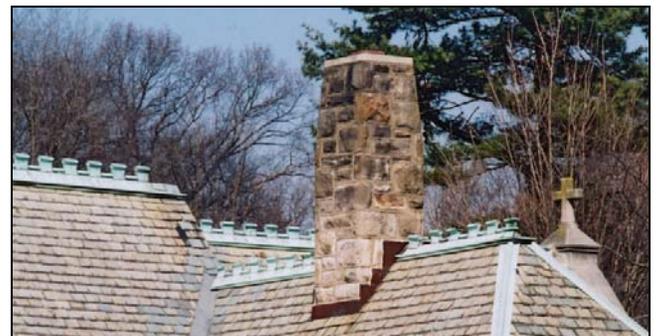
The steeply pitched slate roof, large chimney and the ridge cresting add visual interest to this building.

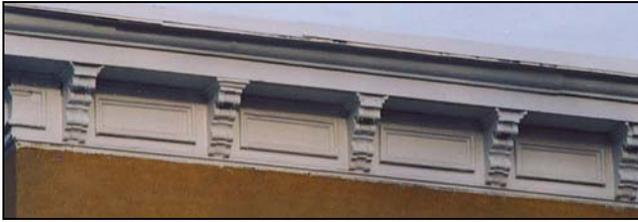
Property owners are encouraged to maintain roof edge features like decorative cornices and trim, and not enclose them in siding.
