Township of Cheltenham

Board of Historical and Architectural Review

GUIDELINES FOR EXTERIOR WOODWORK

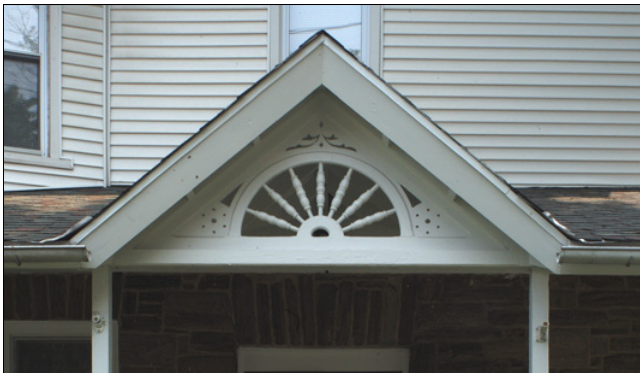
Although the walls of this residence were covered with artificial siding, the decorative wood pediment remains exposed to view.
