Township of Cheltenham

Board of Historical and Architectural Review

GUIDELINES FOR EXTERIOR WOODWORK

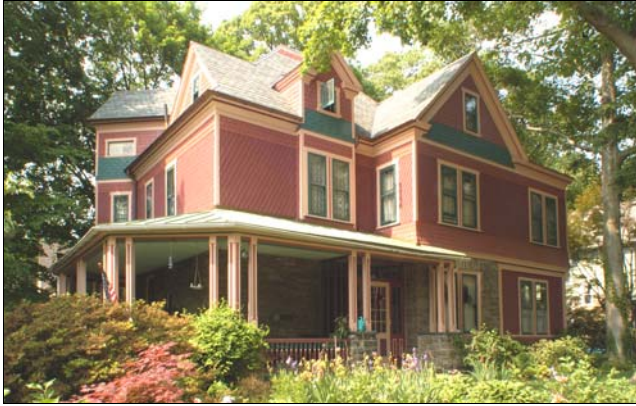
The owner of this Queen Anne home removed the aluminum siding and repaired underlying wood shingles and applied an appropriate paint scheme.

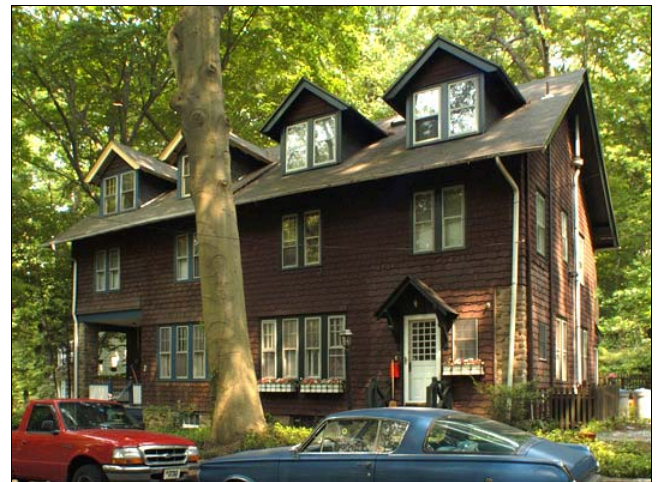
Stained beveled shingles were often used in Arts and Crafts or Craftsman influenced homes. The dark brown color was intended to blend with the natural surroundings.

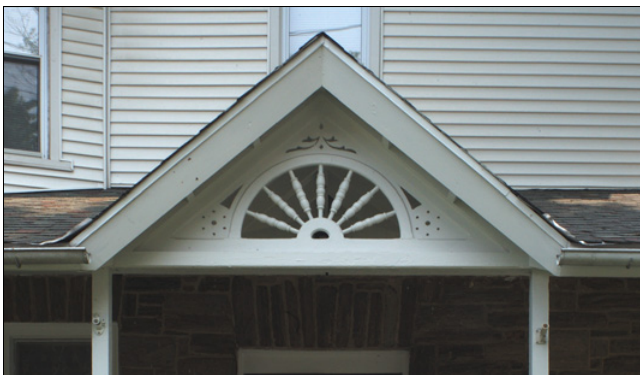
Although the walls of this residence were covered with artificial siding, the decorative wood pediment remains exposed to view.

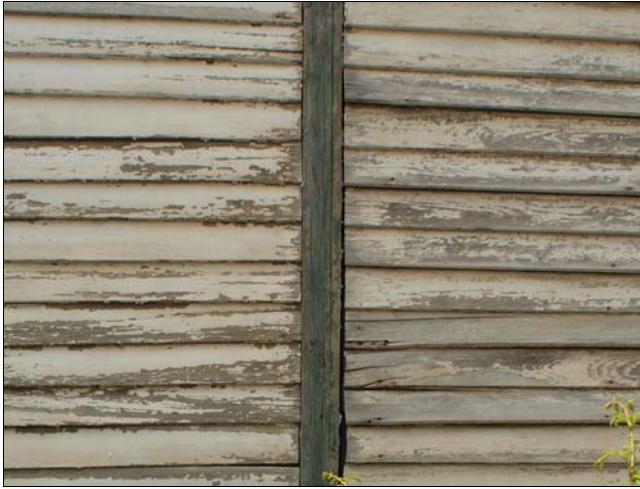
This siding includes visible signs of deterioration. Problems include bare wood from peeling and missing paint, splitting or checking along the grain of the post and siding, and open joints between the siding and post.

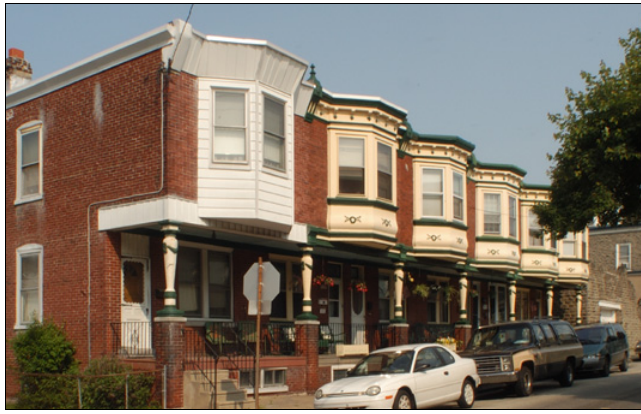
Artificial siding over decorative elements can greatly change the appearance of the streetscape. The artificial siding can trap moisture and deteriorate the underlying woodwork.

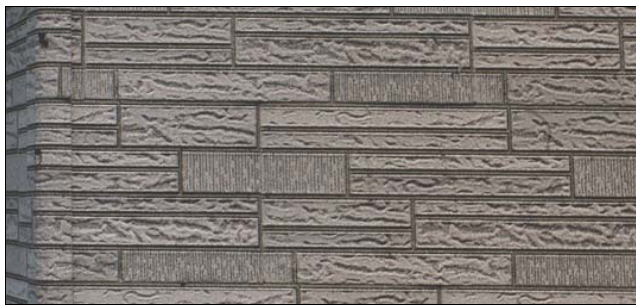
Asphalt siding often simulates brick or stone wall surfaces.

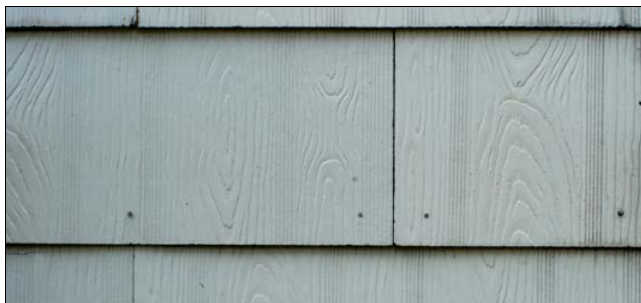
Asbestos siding is often embossed with a wood grain pattern. The removal of asbestos siding can be dangerous and should be undertaken by trained professionals.

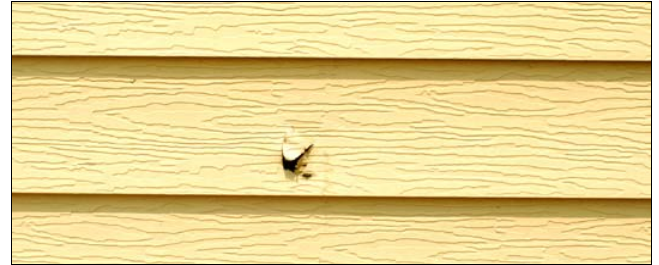
If considering artificial siding, a smooth finish is recommended rather than a wood-grain finish. Replacement of this aluminum siding section would be the best way to repair the puncture. Since siding colors tend to fade from sunlight, the replacement siding probably will not match the existing siding.

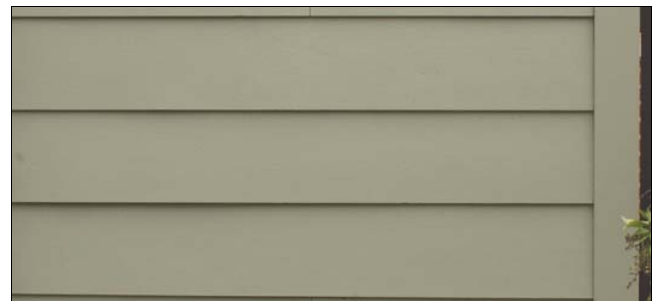
Fiber-cement siding material is a good economical alternative for an addition to an historic house. The surface of the Hardiplank siding above was painted to match the existing paint scheme.

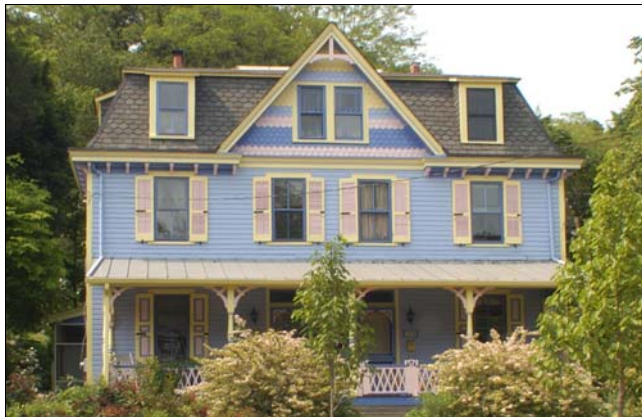
The owners of each half of this semi-detached house repaired the exterior woodwork and applied a uniform paint scheme, making it appear like a larger single home.

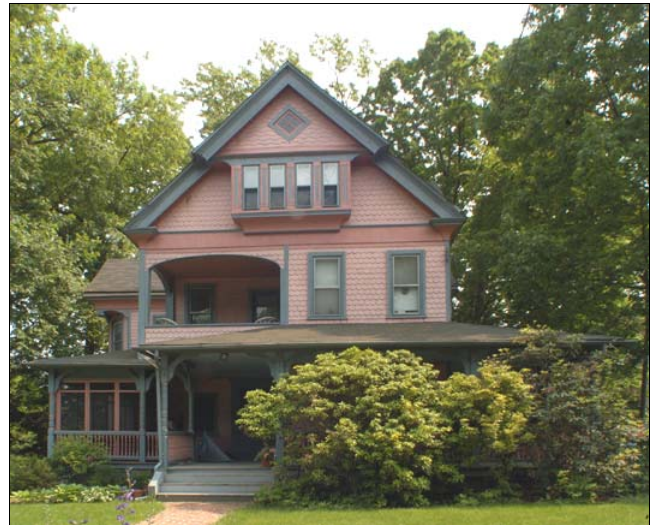
Typical of the Queen Anne style, this home features a variety of decorative exterior wood elements including wavy wood shingles at the front pediment, scalloped shingles on the walls, prominent rake boards along the roof, a projecting oriel window with a decorative diamond pattern at the front gable and bracketed turned wood posts at the front porch.
