Township of Cheltenham

Board of Historical and Architectural Review

GUIDELINES FOR EXTERIOR WOODWORK

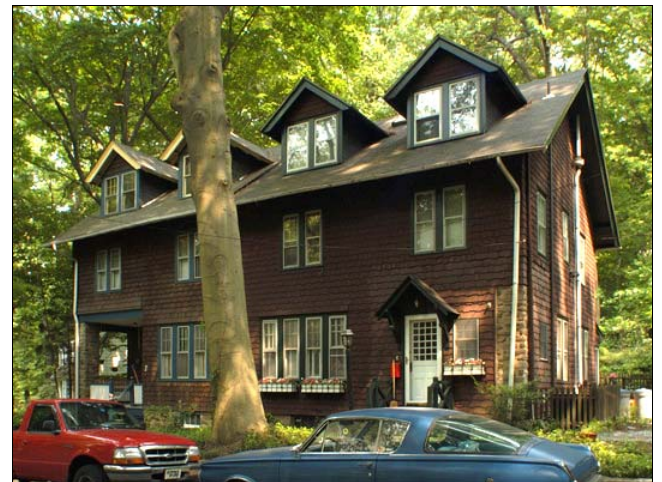
Stained beveled shingles were often used in Arts and Crafts or Craftsman influenced homes. The dark brown color was intended to blend with the natural surroundings.

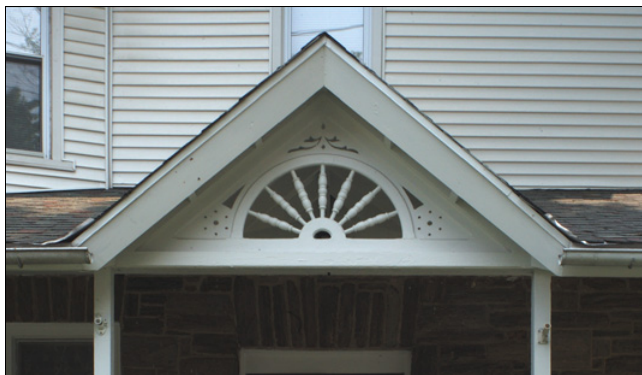
Although the walls of this residence were covered with artificial siding, the decorative wood pediment remains exposed to view.

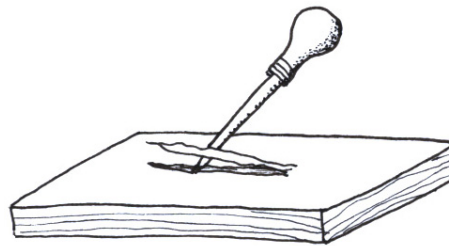
Less penetration and long splinters are an indication of healthy wood

A simple means of testing for rot is to stab the wood member perpendicular to the grain with an awl or ice pick. Then measure the penetration depth and evaluate the type of splintering using the following criteria:

- If the penetration is less than $\frac{1}{4}$ inch, the component does not need replacement
- If the penetration is more than $\frac{1}{2}$ inch, the component might need replacement
- If long splinters are produced, the wood is healthy and the component does not need replacement
- If short sections broken across the grain are produced, the component might need replacement

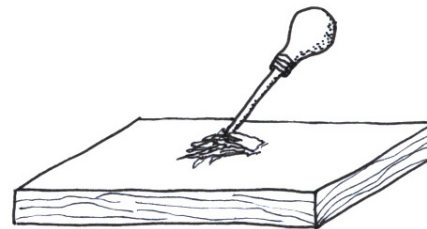
Greater penetration and short splinters against the grain are a possible indication of rot

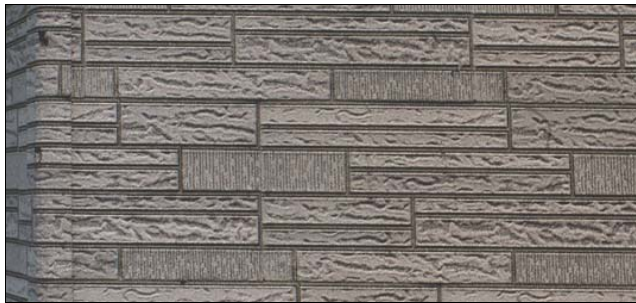
Asphalt siding often simulates brick or stone wall surfaces.

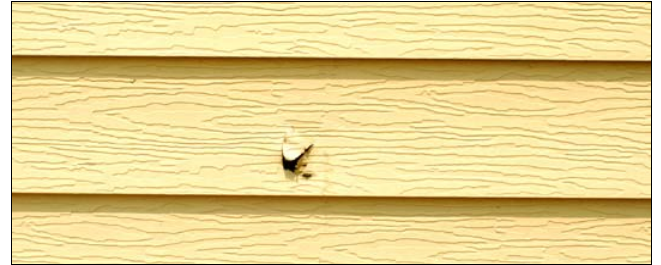
If considering artificial siding, a smooth finish is recommended rather than a wood-grain finish. Replacement of this aluminum siding section would be the best way to repair the puncture. Since siding colors tend to fade from sunlight, the replacement siding probably will not match the existing siding.

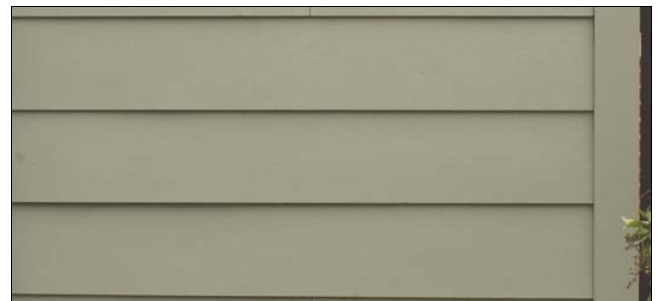
Fiber-cement siding material is a good economical alternative for an addition to an historic house. The surface of the Hardiplank siding above was painted to match the existing paint scheme.

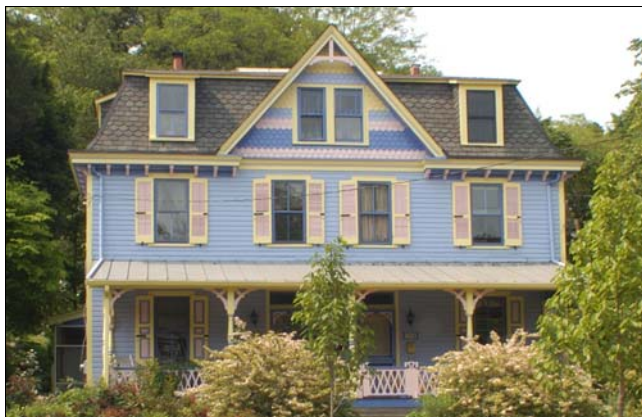
The owners of each half of this semi-detached house repaired the exterior woodwork and applied a uniform paint scheme, making it appear like a larger single home.
