Township of Cheltenham

Board of Historical and Architectural Review

GUIDELINES FOR EXTERIOR WOODWORK

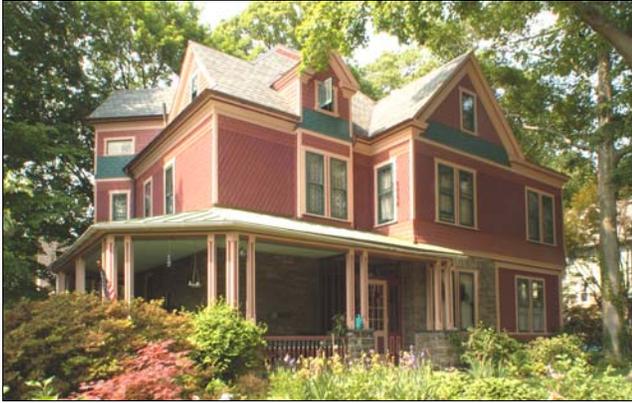
The owner of this Queen Anne home removed the aluminum siding and repaired underlying wood shingles and applied an appropriate paint scheme.

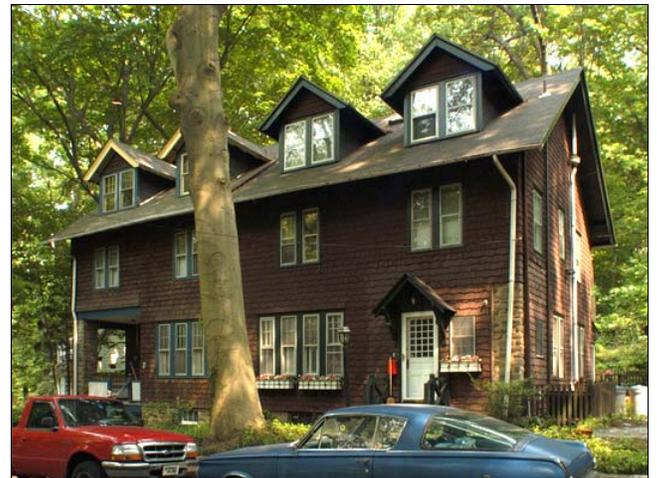
Stained beveled shingles were often used in Arts and Crafts or Craftsman influenced homes. The dark brown color was intended to blend with the natural surroundings.

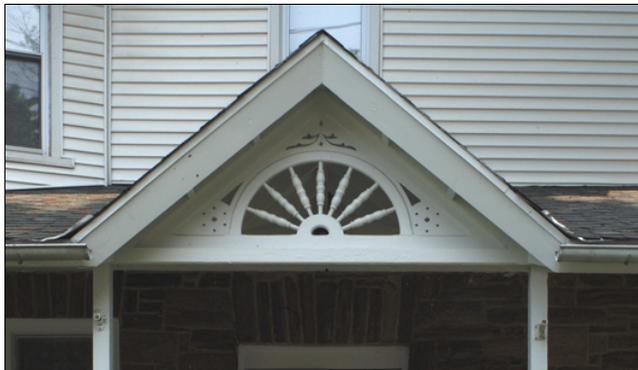
Although the walls of this residence were covered with artificial siding, the decorative wood pediment remains exposed to view.

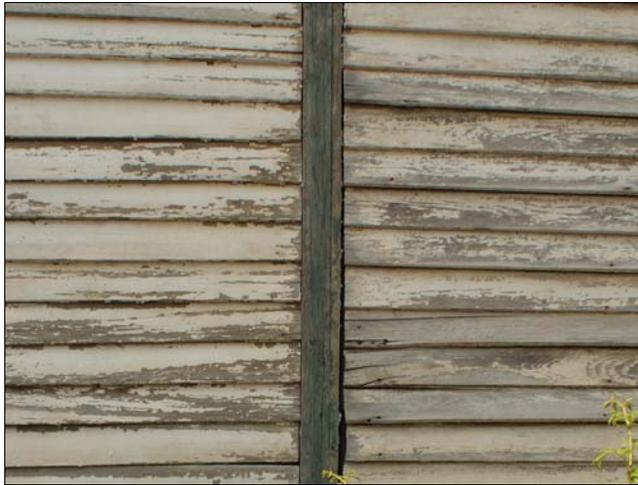
This siding includes visible signs of deterioration. Problems include bare wood from peeling and missing paint, splitting or checking along the grain of the post and siding, and open joints between the siding and post.

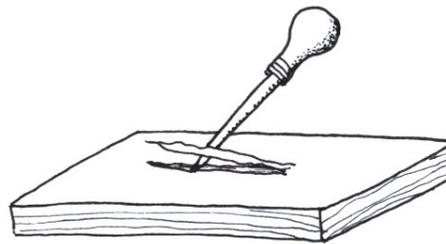
Less penetration and long splinters are an indication of healthy wood

A simple means of testing for rot is to stab the wood member perpendicular to the grain with an awl or ice pick. Then measure the penetration depth and evaluate the type of splintering using the following criteria:

- If the penetration is less than $\frac{1}{4}$ inch, the component does not need replacement
- If the penetration is more than $\frac{1}{2}$ inch, the component might need replacement
- If long splinters are produced, the wood is healthy and the component does not need replacement
- If short sections broken across the grain are produced, the component might need replacement

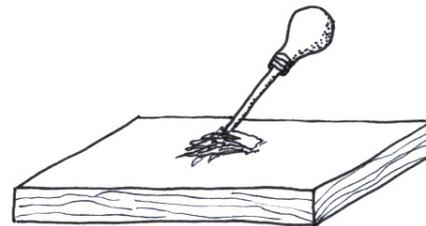
Greater penetration and short splinters against the grain are a possible indication of rot

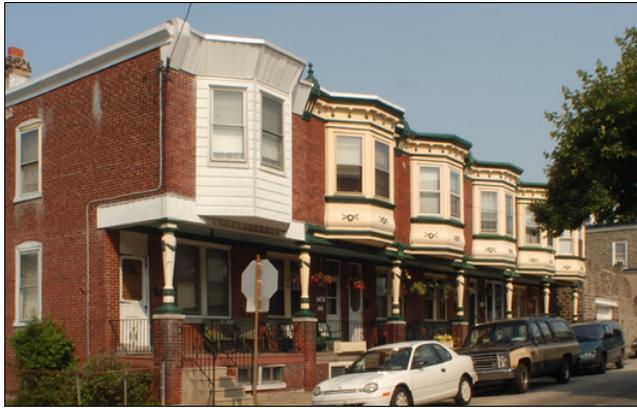
Artificial siding over decorative elements can greatly change the appearance of the streetscape. The artificial siding can trap moisture and deteriorate the underlying woodwork.

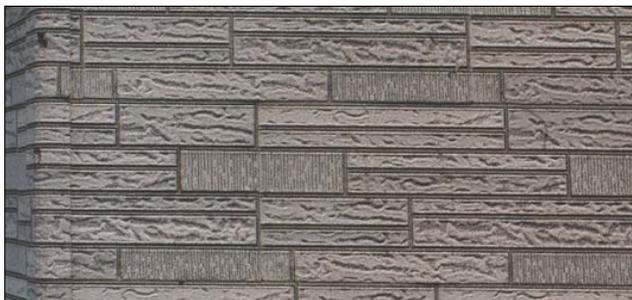
Asphalt siding often simulates brick or stone wall surfaces.

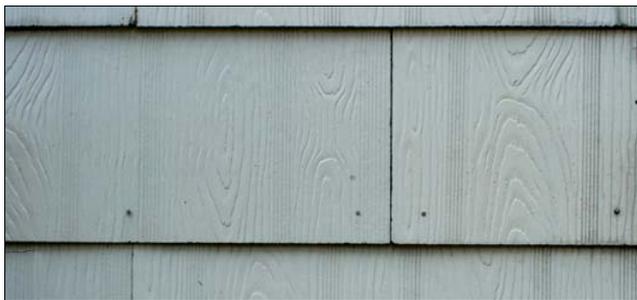
Asbestos siding is often embossed with a wood grain pattern. The removal of asbestos siding can be dangerous and should be undertaken by trained professionals.

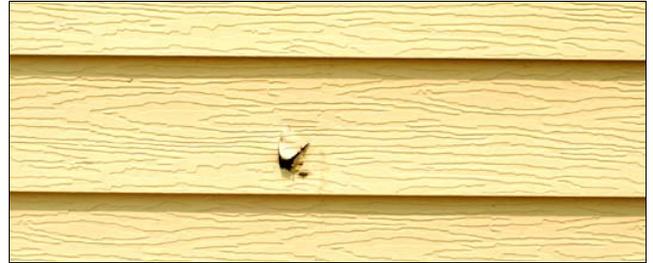
If considering artificial siding, a smooth finish is recommended rather than a wood-grain finish. Replacement of this aluminum siding section would be the best way to repair the puncture. Since siding colors tend to fade from sunlight, the replacement siding probably will not match the existing siding.

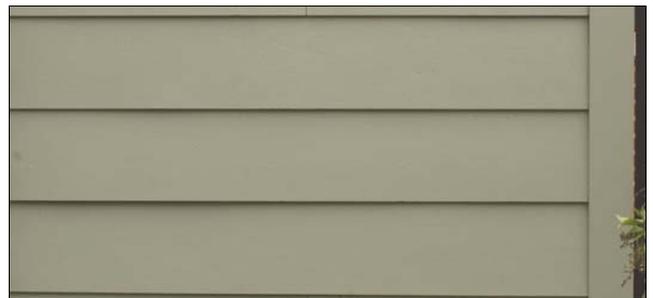
Fiber-cement siding material is a good economical alternative for an addition to an historic house. The surface of the Hardiplank siding above was painted to match the existing paint scheme.

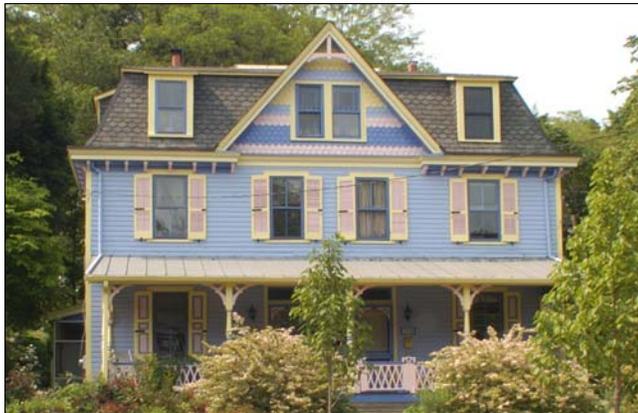
The owners of each half of this semi-detached house repaired the exterior woodwork and applied a uniform paint scheme, making it appear like a larger single home.

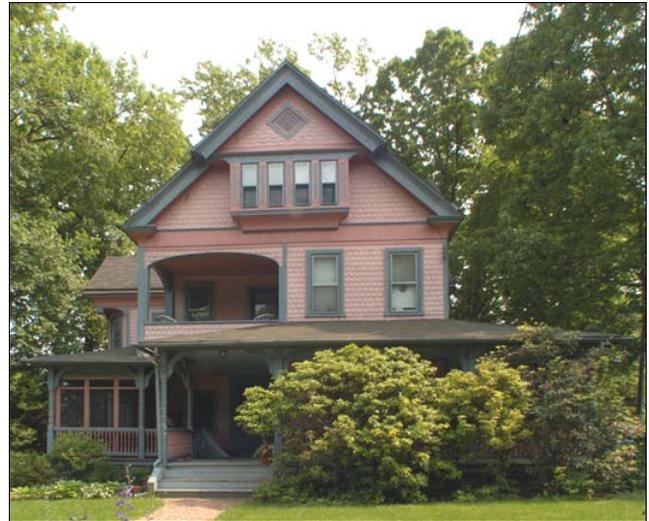
Typical of the Queen Anne style, this home features a variety of decorative exterior wood elements including wavy wood shingles at the front pediment, scalloped shingles on the walls, prominent rake boards along the roof, a projecting oriel window with a decorative diamond pattern at the front gable and bracketed turned wood posts at the front porch.
