Where Growth is a Tradition

HISTORIC WINDOWS AND SUSTAINABILITY

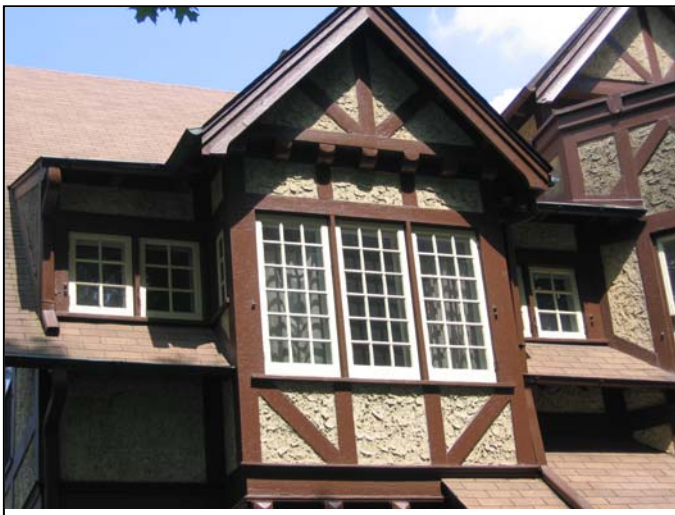
Historic, wood casement windows
in the Wyncote Historic District.

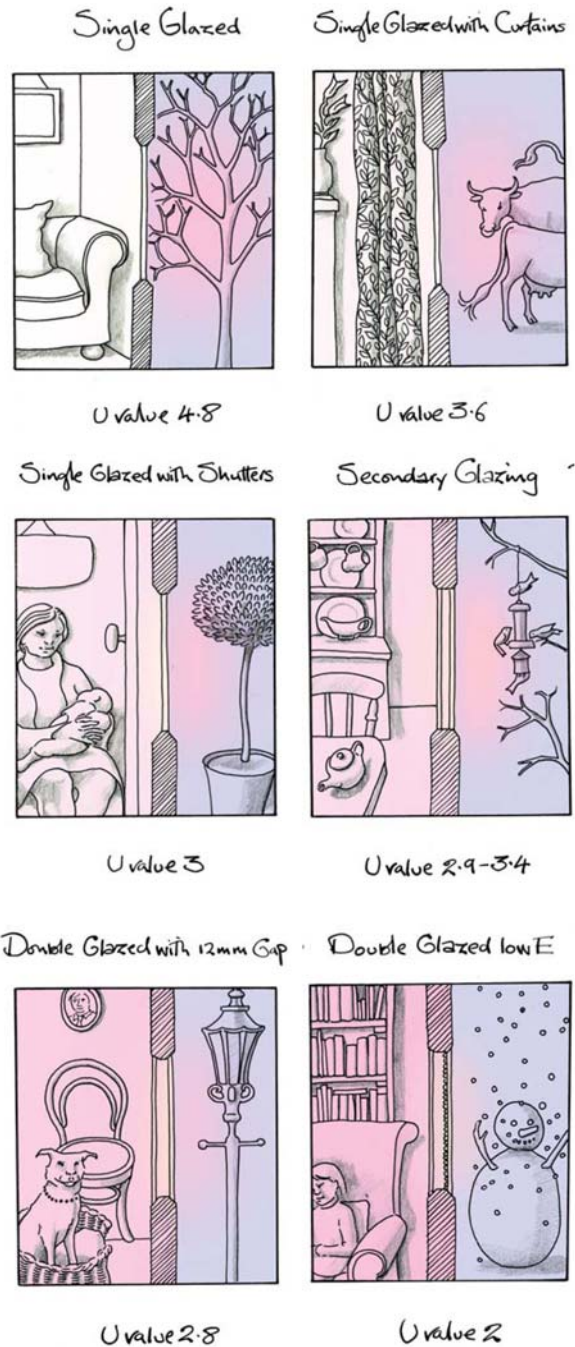
Different U-factors for alternate window configurations and treatments (Note that this graphic originates from the United Kingdom, where the U-Factor is referred to as the U Value. Graphic is from "Energy Conservation in Traditional Buildings," printed by English Heritage in 2008. Accessible at http://www.climatechangeandyourhome.org.uk/live/content_pdfs/526.pdf).

Based on testing performed for English Heritage, officially known as the Historic Buildings and Monuments Commission for England, it was found that a properly functioning historic window assembly (including both the sash and frames) has a U-factor of approximately 4.3. When this same window was combined with other traditional elements, the U-factor dropped substantially: with

heavy curtains it was 2.5, with well-fitting shutters 1.7, with a reflective rolling blind 1.9, and a honeycomb blind 2.1. When the properly functioning wood window assembly is combined with a low-emissivity (low-E) secondary glazing (a storm window) the U-factor drops to 1.8. This translates to a 58% reduction in the heat lost through the window assembly.³

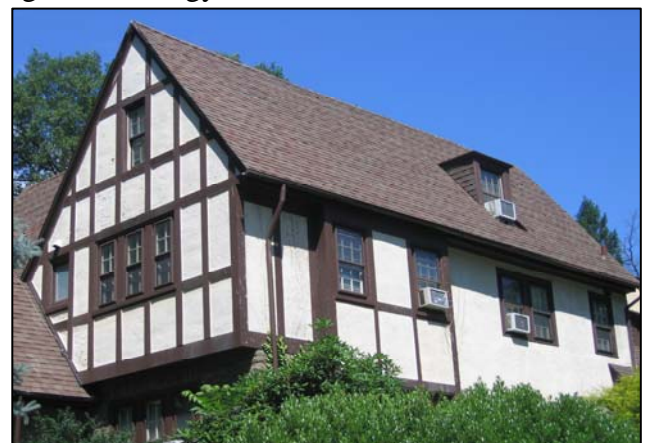
Historic, wood double-hung sash windows with modern storm windows in Wyncote.

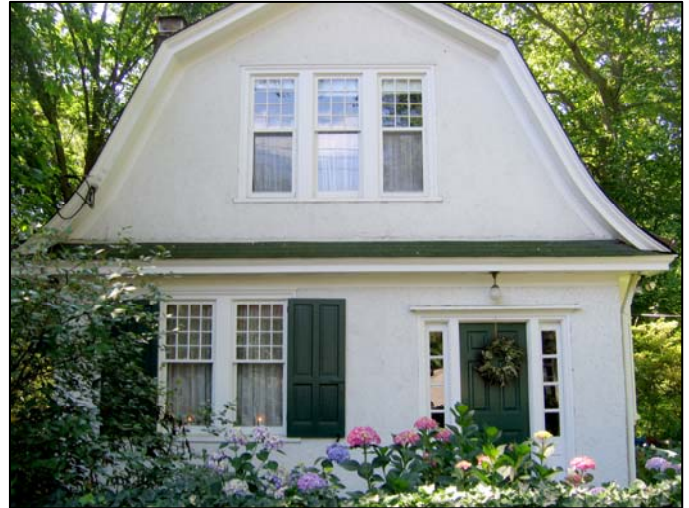
This dwelling in Wyncote has properly maintained, historic, wood, double-hung sash windows with operational shutters.

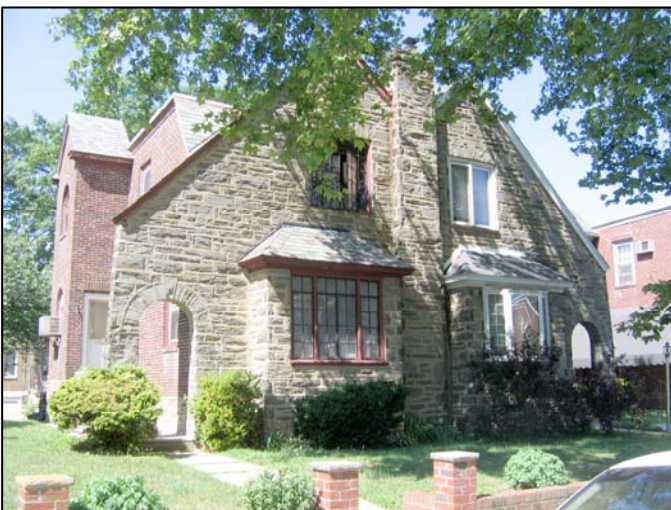
These semi-attached dwellings in the La Mott Historic District illustrate the role that windows play in the appearance of a building. The dwelling on the left has the original steel casement windows, whereas the one of the right has modern vinyl windows.

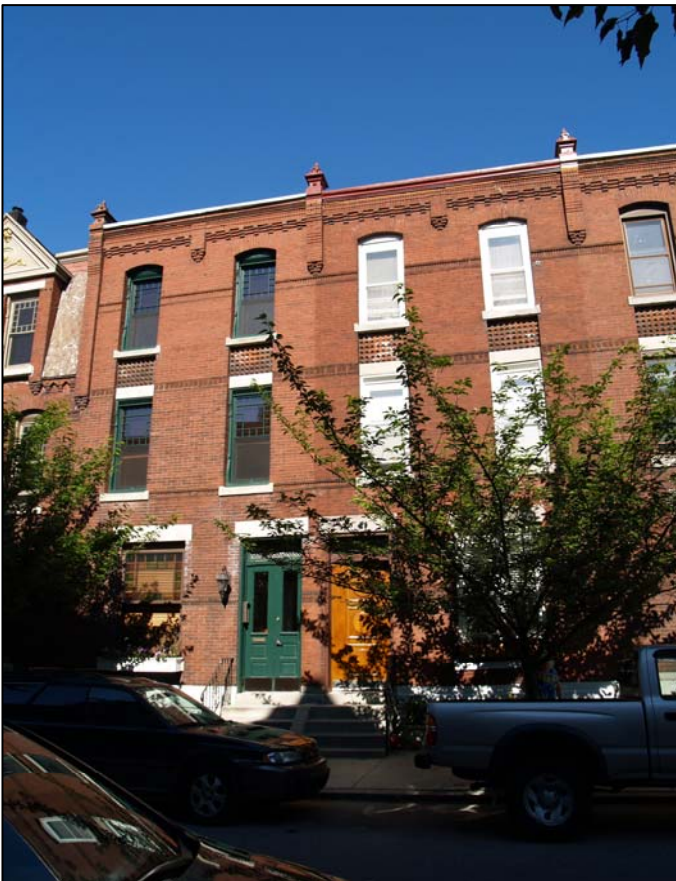
Replacement windows can alter the overall appearance of historic buildings, as illustrated in these row houses. The fiberglass windows on the left mirror the original Queen Anne configuration and maintain a narrow frame profile. The vinyl windows on the right are less sympathetic to the original design of the building.

Fiberglass windows tend to be slightly more costly than stock vinyl windows, but the durability of fiberglass far exceeds that of vinyl. Fiberglass is a stronger material than vinyl, allowing the sash and frames to be thinner in proportion. This allows for a greater retention of glazing surface area, since vinyl windows require a thick profile.

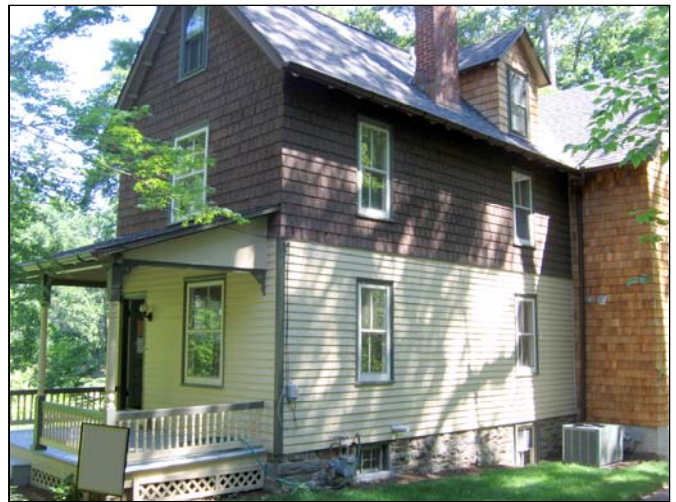
The historic wood windows on this property were repaired and storm windows were installed.

After historic windows have been properly repaired, their performance in terms of energy efficiency increases. Combined with storm windows, properly repaired historic windows have the dual benefit of longevity (in some cases more than 200 years) and can virtually meet the performance of modern replacement windows, which have a much shorter lifespan.

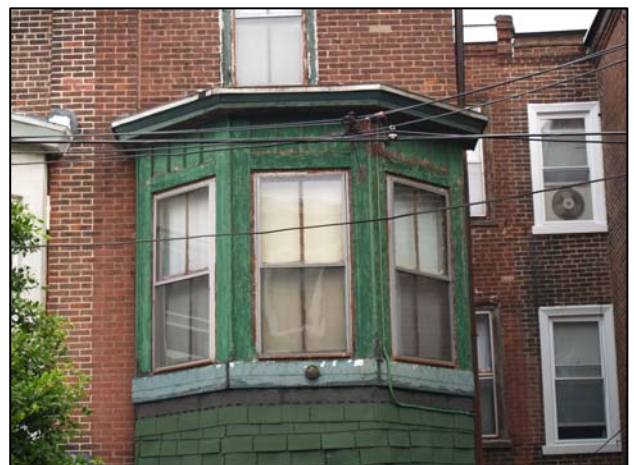
Windows in poor condition require intervention to maximize your home's energy efficiency.
